Safety Inspection Report

Annual Inspection

Church Lane

Weston on the Green Parish Council

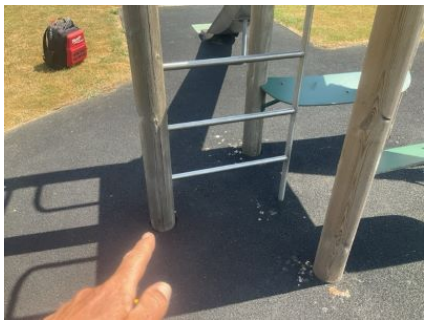
Timber is decayed.

Slight increase in decay form the last annual inspection. Program in replacement.

Medium

8

Read the notes for further action.
